POTOMAC RIVER BASIN

**Name Of Dam:** OCCOQUAN RESERVOIR SYSTEM

**Inventory Number:** OCCOQUAN "UPPER" MAIN DAM, VA 15304  
OCCOQUAN "LOWER" STORAGE DAM, VA 15305

## PHASE I INSPECTION REPORT NATIONAL DAM SAFETY PROGRAM

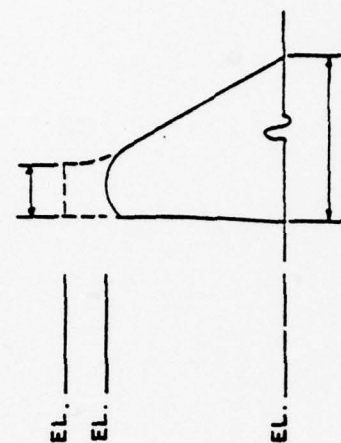
PARTIAL SECTION

LOADING CASE	ELEV. HEAD WATER	ELEV. TAIL WATER	$\Sigma V$	$\Sigma H$	$\frac{\Sigma H}{\Sigma V}$	LOCATION RESULTANT FROM TOE	% BASE COMPRESSION IN	FACTOR SAFETY SLIDING	FOUNDATION PRESSURE	
									TOE	HEEL
NORMAL OPERATION	120	-	61.2	19.5	0.32	14.29	100	23.	1.65	3.05
* P.M.F.	142	112	55.4	55.4	1	2.6	30	8.	14.2	-
$\frac{1}{2}$ P.M.F.	135	91	48.9	49.1	1	3.8	45	9.	8.6	-
* $\frac{1}{2}$ P.M.F.	135	91	65.4	49.1	0.75	7.2	83	9.	6.0	-

\*WITH DRAINS WORKING
